# Bilbao Exhibition Centre, Spain

J. J. Martínez de Aragón, F. Rey  
*Labein – Technological Centre, Spain*

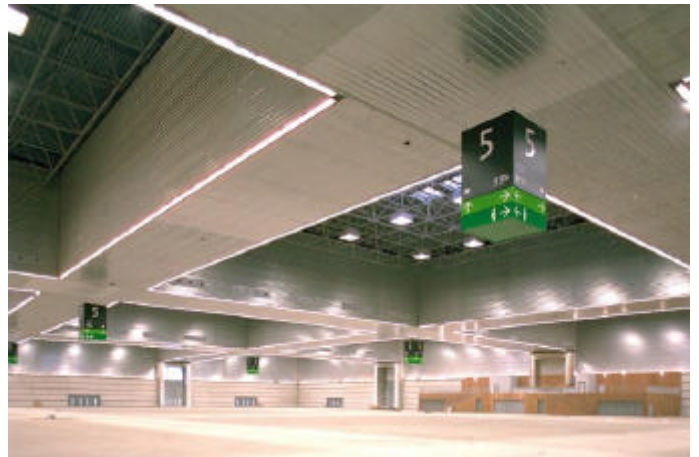
Figure 2. Internal view of Hall n°5

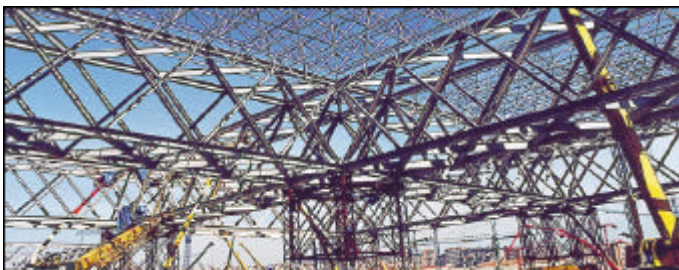
The columns are of reinforced concrete. The box beams are composed of four trussed beams and are made of structural steel.

Figure 3. Hall structure during erection

The box trussed beams of the halls are 125÷167 m long. The roof tubular spatial structure consists of 60 panels (37x37m).

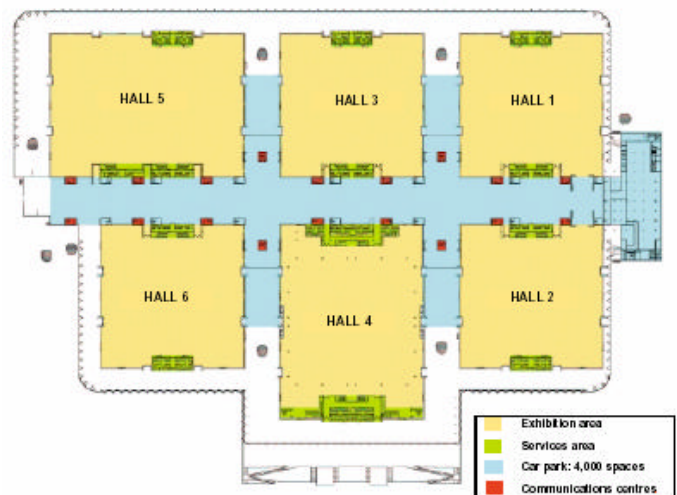
Figure 4. Plan drawing of BEC
